CATHODIC PROTECTION SYSTEM

FOR FLEET MOORINGS

CATHODIC PROTECTION SYSTEM FOR FLEET MOORINGS

Technical Report R-702

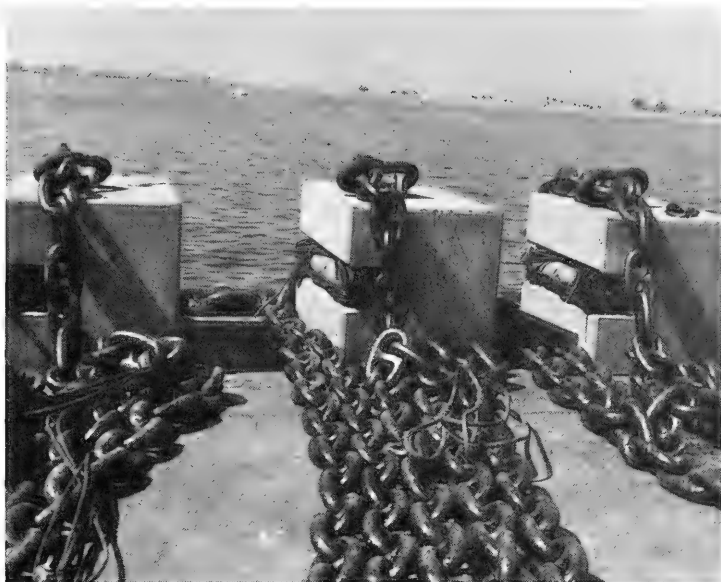
Figure 7. Sinker blocks housing cathodic protection units with coiled cables prior to laying of system.

Three days after the mooring had been layed, the cathodic protection units on the ground legs were connected for service. Two of the four sinker blocks were found by divers to be lying on the side containing the unit. The blocks were righted, and the ground cables on each unit were uncoiled and connected as follows. The free end of the cable from the control head and the free end of the cable attached near the ground ring were brought to the surface. The lugs on each end were joined with a nut and bolt and were silver-soldered together to insure electrical continuity. The joined cables were then allowed to sink to the bottom of the bay. The second cable on the control head and the cable attached near the anchor were similarly joined to give the electrical circuitry shown in Figure 1. The riser-chain was then shortened to 23 feet so that the ground ring just touched bottom at mean lower low water in this 38-foot-depth location.

Installation. The entire mooring complex was placed on the deck of a floating crane in position for laying (Figure 6). The two ground cables connected to the control head in each sinker block were coiled and tucked inside the groove in the block (Figure 7) to protect them from damage during laying operations. A 75-foot length of similar cable was welded to the second A-link from the ground ring, and a 50-foot length of cable was welded to the second A-link from the anchor of each ground leg. These cables were also coiled tightly and tied in place prior to laying operations. A tight mooring was carefully placed in its assigned location in the San Diego Bay.

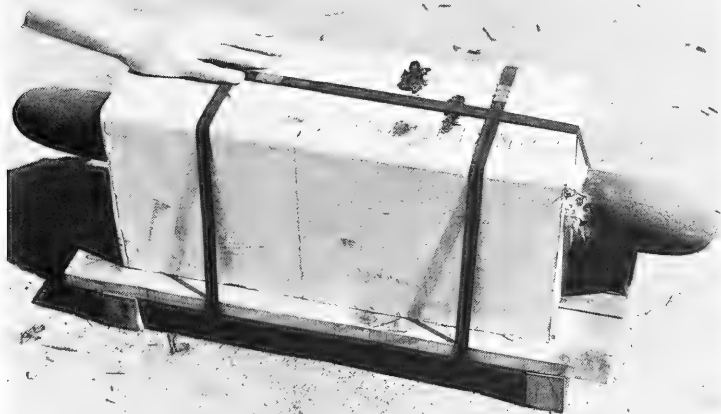
Figure 9. Specially cast zinc anode on chain link.

While the ground legs were out of the water, each anode was examined. There was no sign of passivation, and plenty of zinc remained for further use. Zinc losses occurred in irregular pits rather than in a uniform manner.

The anodes in the new cathodic protection system had to be specially manufactured. They were prepared by casting SA-3 zinc alloy on a 2-1/2-inch-thick, 35-inch-long steel link. The zinc casting was 1.8 feet long, was approximately 6.6 ft² in total surface area, and had a trapezoidal cross section. The entire anode weighed approximately 485 pounds (Figure 9).

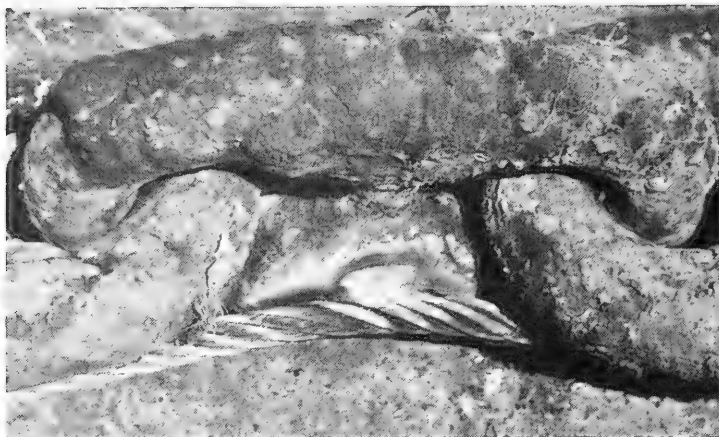
Figure 12. Cable silver-soldered to chain link.

A potential profile was made on the entire mooring 1 week after the two ground legs had been modified, and the readings are listed in Table 6. They indicate that, while the sandblasting had little effect, the cables provided the necessary continuity for complete cathodic protection. Because of the very promising results with the cable-modified leg, the cathodic protection design was further modified to include cables for all of the ground legs.

In order to determine ways to obtain better electrical continuity between chain links, two of the ground legs were slightly modified 8 months after the readings of Table 5 were made. One leg was removed from the water, and those portions of the chain links that come into contact with each other were sandblasted using the portable sandblast equipment aboard a floating crane. This ground leg was then returned to its normal location underwater. A second ground leg was removed from the water and layed out on the deck of the floating crane. Three 3/4-inch-diameter galvanized steel cables were woven back and forth through every sixth link. One cable extended from the A-link nearest the anchor to the A-link nearest the zinc anode 45 feet away. The other two cables extended between the zinc anodes which were 90 and 80 feet apart. The ends of each cable were silver-soldered to the A-link nearest the anode (Figure 12), and the cable was also silver-soldered approximately every 9 feet to the chain. Sufficient slack was allowed between fixed positions so that there was no strain on the cable. This ground leg was then returned to its normal position with no difficulty.

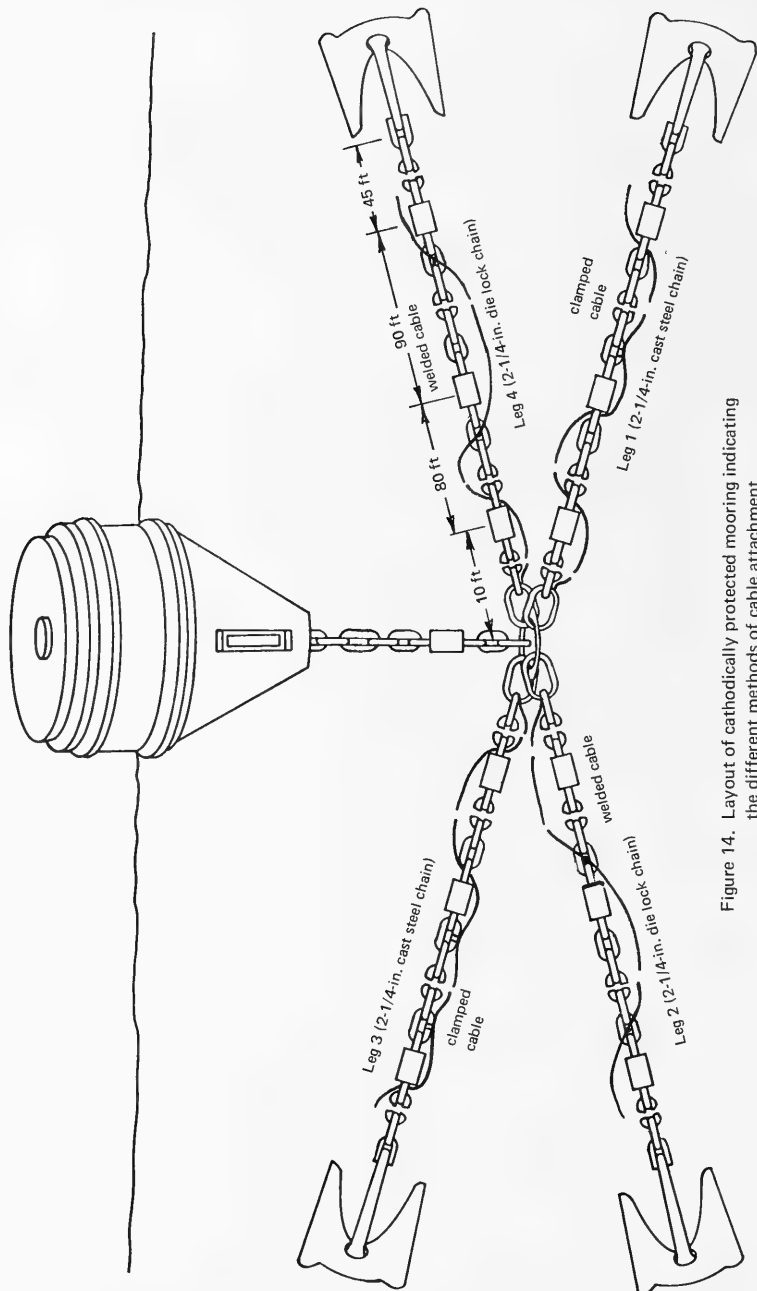
Figure 14. Layout of cathodically protected mooring indicating the different methods of cable attachment.

Performance. A potential profile of the modified mooring was made approximately 3 weeks after the mooring was laid, giving the data listed in Table 7. It can be seen from these data that all readings were well above the desired minimum level of -850 mv and most were above $-1,000$ mv. Two of the four anchors were also receiving cathodic protection despite the attempt to prolong anode life by avoiding this.

The modified cathodic protection design is shown in Figure 14. A single length of galvanized steel cable was loosely woven back and forth through every sixth link of each leg and was joined to the chain approximately every 5 feet. On two of the legs the joints were accomplished by silver soldering, and on the other they were accomplished with pipe clamps (Figure 15). The advantages of joining with pipe clamps were (1) it was faster, (2) it did not require the services of a welder, and (3) it did not require heating which might slightly decrease the strength of the heated link. The clamps were snapped into position and were then further tightened with a screwdriver. One pipe clamp was installed by a diver at the time of a later inspection to demonstrate that securing the cable underwater presented no real difficulty.

As shown in Figure 14, Legs 1 and 3 were of 2-1/4-inch cast steel chain with 3/4-inch galvanized steel cables clamped to them; Legs 2 and 4 were of 2-1/4-inch die lock chain with 3/4-inch galvanized steel cables welded to them. The cable on each leg was terminated approximately six links from the jew's harp of the anchor, rather than at the A-link nearest the anchor as in the previous test, to minimize current loss to the anchor. Thus, full protection of the chain was desired rather than partial or complete protection of the anchor.

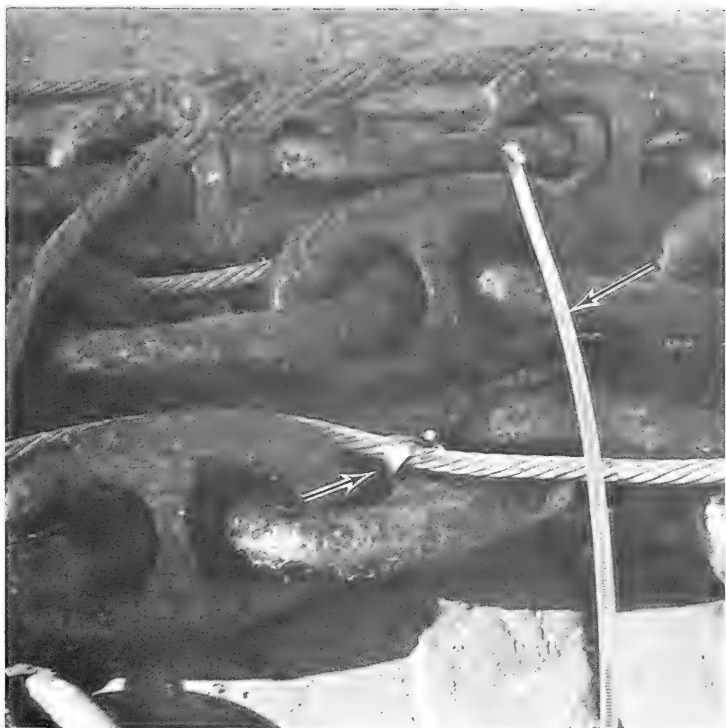
Figure 15. Cable clamped to chain link and a clamp shown prior to use.

The mooring chains were also in excellent condition. The mooring crew remarked that they looked as good as the day they were installed. Not only was corrosion negligible, but the coating was in good condition. The anodes had a loose, yellowish film but no fouling on them. They showed no signs of passivation, such as was found by Peterson and Waldron¹⁵ on zinc anodes in the San Diego Bay. It was not practical to weigh the anodes, but based on a visual inspection it was estimated that they would have an effective service life of at least 8 years. The cables that were silver-soldered to two of the ground legs had suffered localized damage at two points. Apparently the cables were damaged in these areas by the heat from the torch used in silver soldering and were later pulled apart during handling, either in laying or picking up the mooring. Before relocating the mooring, repairs were made by silver soldering the broken cables and then clamping them to the chains with pipe clamps. In a few places where the silver-soldered joint between the cable and chain had been broken without damage to the cable, repairs were also made by clamping the cable back into position. No apparent damage to the pipe clamps used on the other two ground legs could be detected.
